# **Sprayed Foam Insulation applied to pitches of existing roofs in domestic buildings**

**Information Paper containing observations  
and recommendations for members of the  
Property Care Association**

**November 2021**

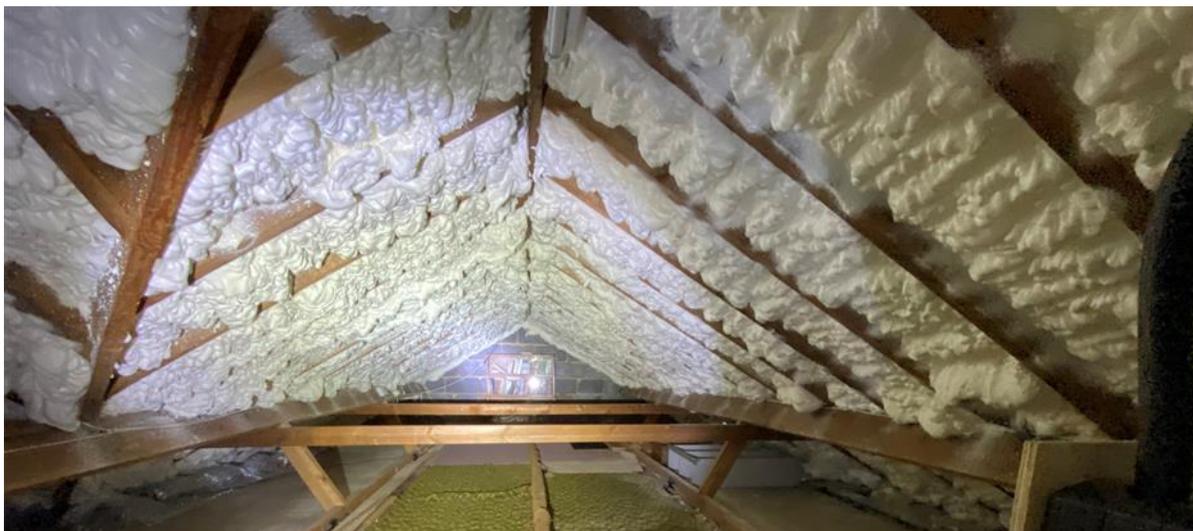
Fig 1. Open Cell PU foam

These products are vapour permeable and will allow vapour transfer. Open cell foam is not recommended for applications directly to the underside of tiles, slates, or other domestic roof coverings. These foams should only ever be applied to the underside of vapour permeable roofing felts and breather membranes. In this way the risk of fungal decay and moisture related problems are minimised.

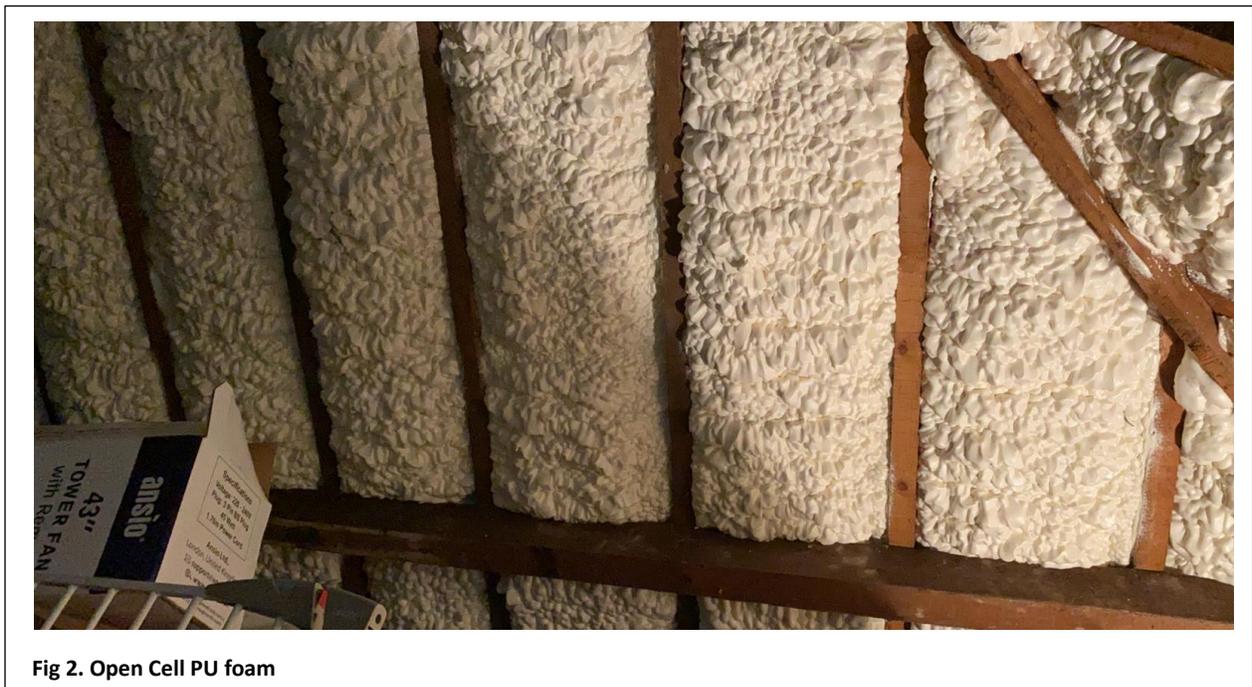
The presence of sprayed foam means that a simple visual inspection to establish the condition of roof timbers is impossible. Investigations performed to establish the condition of roof timbers will be difficult and limited.

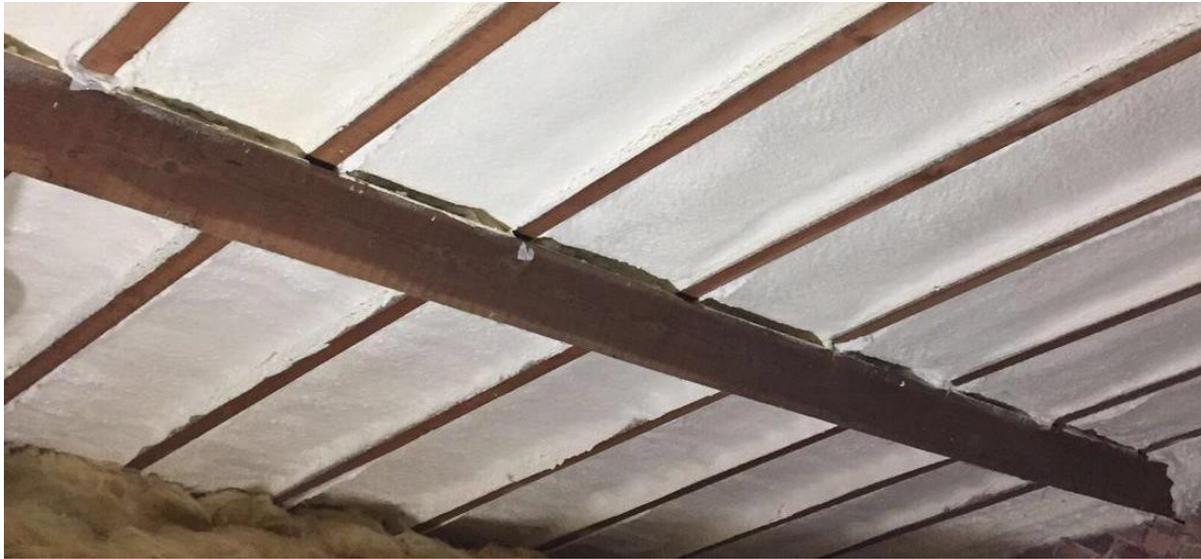
**Fig 3. Closed cell PU foam**

When used to stabilise failing roof coverings it is applied to a “dry” and defect free roof, the use of adhesive PU foams may work to delay the inevitable renewal of roof coverings.

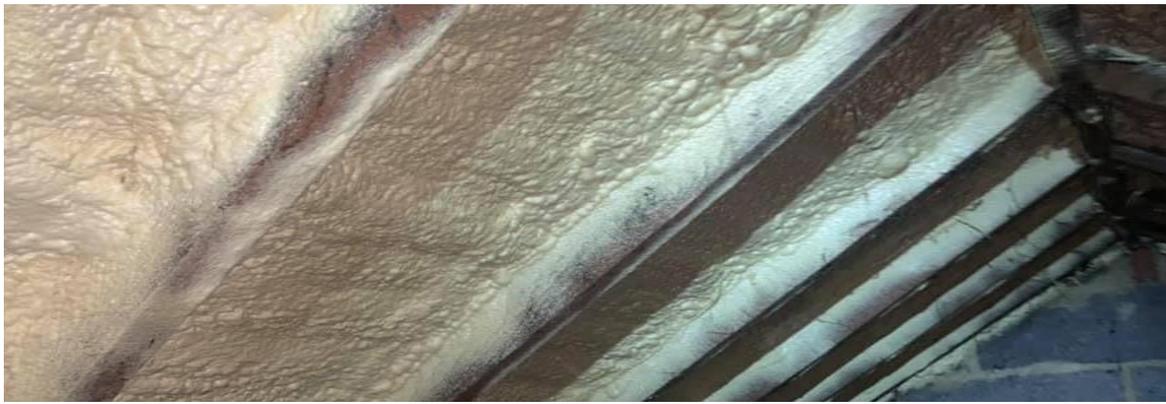
Where timber decay or insect attack is discovered in a roof that has been coated in closed cell foam that has been applied directly to the roof coverings, it is likely that this will result in the full strip and recover of the roof as the foam will be extremely difficult to remove from localised areas.

**Fig 4. Closed cell PU foam**

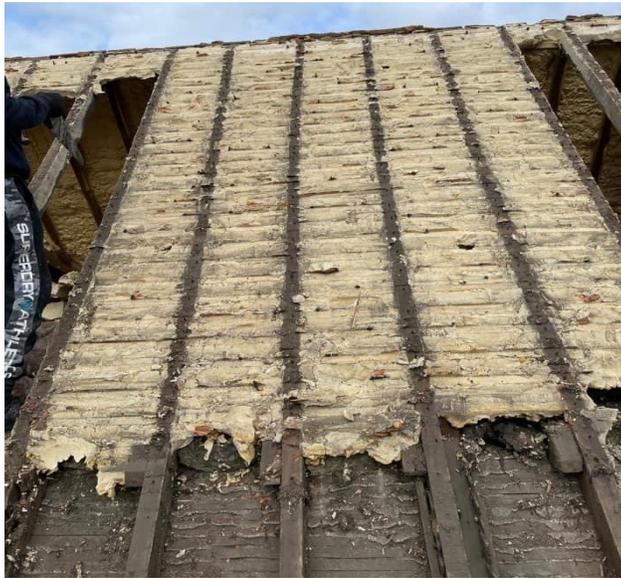
**Fig 5. Closed cell PU foam applied to the extent of the available access from the void. This has left an uninsulated / bonded section of roof / ceiling in the room below. The foam has also eliminated ventilation into what should have been a cold roof void.**

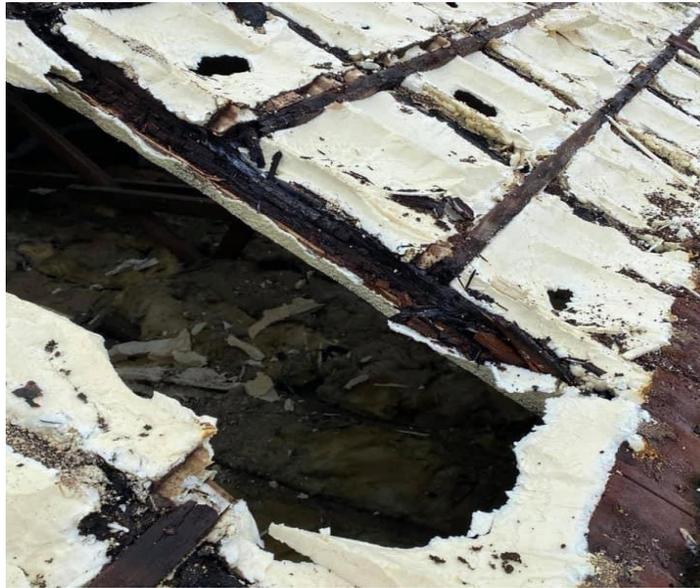
**Fig 6. Closed cell foam used to stabilise a roof that has subsequently failed**

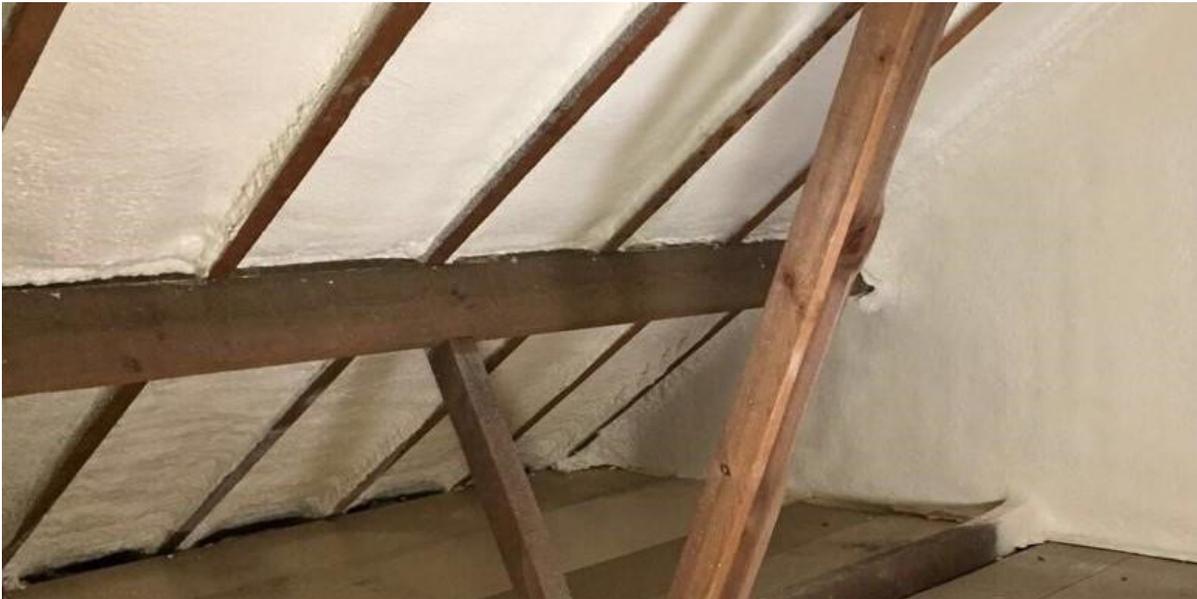
**Fig 7. Closed cell PU foam applied to roof pitches and gable wall. Without detailed information from the installer, or opening up, it is not possible to assess the condition of purlin ends as they bear into the gable masonry or the wall plates or see if a breather membrane exists between the foam and roof coverings. Establishing if the void as a warm or a cold space (that should be adequately ventilated) may also be difficult here?**

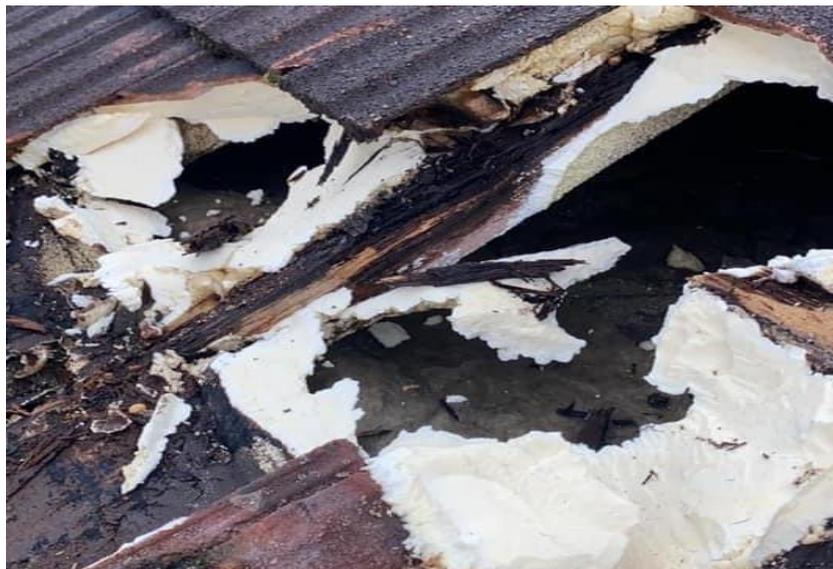
**Fig 8. PU foam concealing the extent of decay in a tiled roof**
