## **Guidance Document:**

# **Hygroscopic Salts and Rising Dampness**

**July 2020**

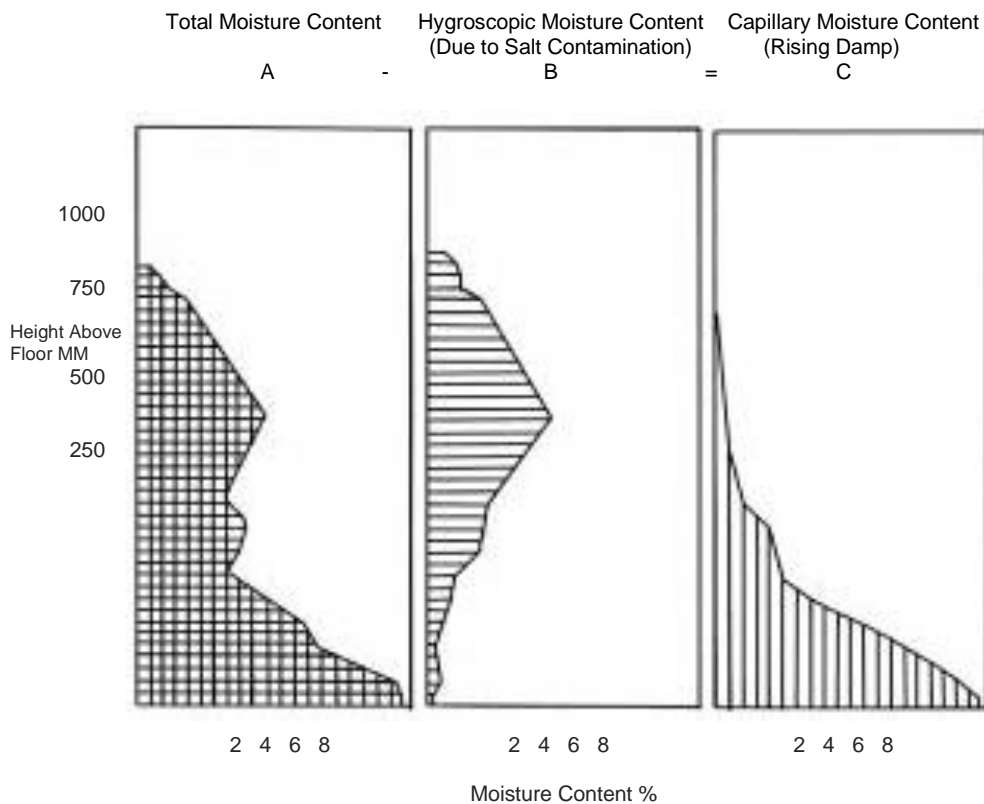
The amount of water absorbed by salt contaminated masonry, mortar, or plaster will vary with the humidity of the air and the amount and character of the salt. A typical distribution of dampness in a wall affected by rising dampness is shown in Figure (2). The diagram shows in graph form, the moisture content of a wall affected by rising dampness:

- A shows the total moisture content.
- B shows the hygroscopic moisture content measured at 75% relative humidity. This represents the amount of water absorbed by the masonry from air at 75% relative humidity.
- C shows the difference A-B and represents water in the wall due to capillary flow.

**Figure (2):** Graph (b) shows that the amount of water absorbed by the masonry from air is about 5% at 600mm above floor level. The hygroscopicity of uncontaminated masonry is 0.1-0.2%. The additional water absorption is due to salt contamination.
