Sprayed Foam Insulation

Inspection Protocol for building professionals who are asked to consider spray polyurethane foam that has been applied to the pitched elevations of domestic roofs.

March 2023

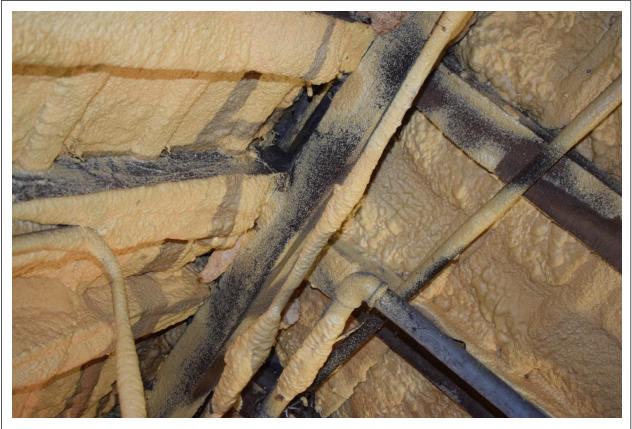
Image: Tile stabilising closed cell spray foam

- Where foams have been applied directly to the primary roof coverings as a means of improving thermal performance or to stabilise failing roof coverings or have been applied directly to underlays that are considered to be of high vapour resistance, an assumption may be made that such installations are high risk.

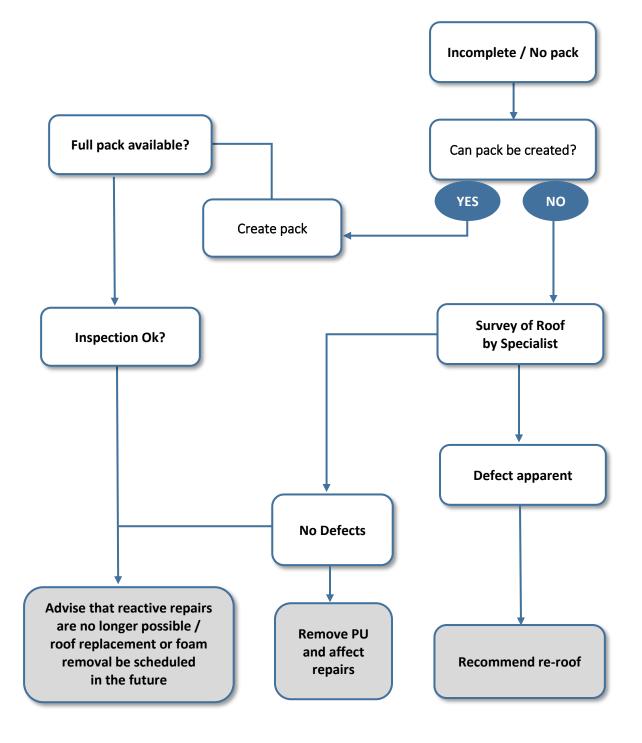
Sprayed polyurethane foam applied directly to primary roof coverings where no underlay/roofing felt is present

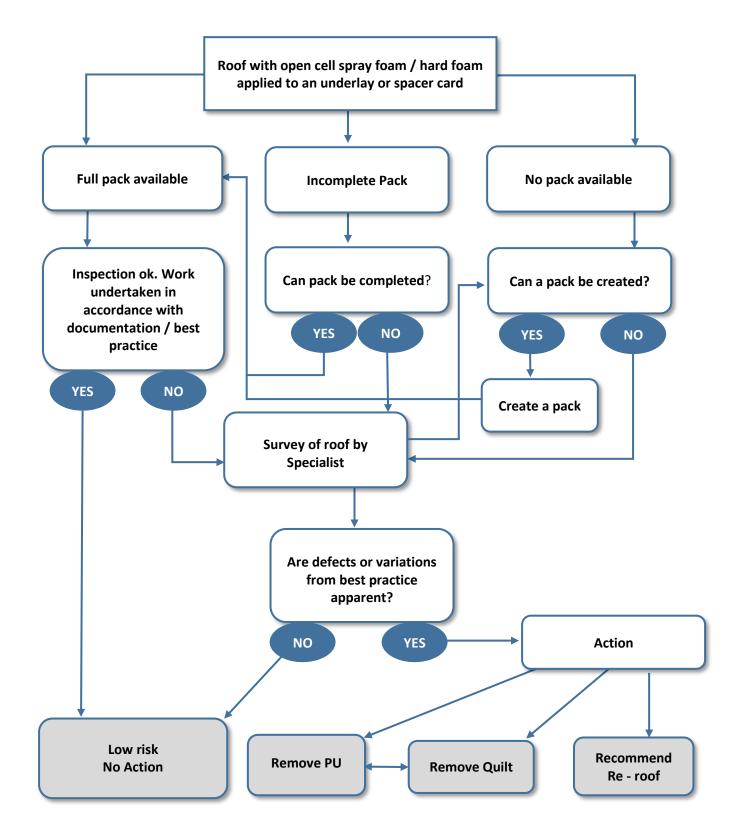
Sprayed polyurethane foam applied to a roof that incorporates an underlay / roofing felt
