# PCA Case Study

## Flood Remediation

Reinstatement of a terraced property in Ottery St Mary after flooding, using cavity drain membrane, allowing the owner to move back in many months earlier than expected.

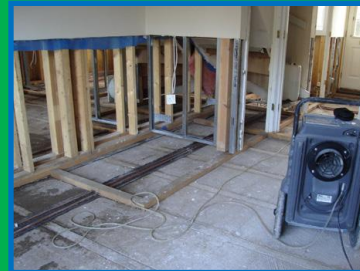
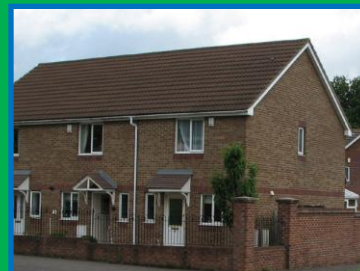
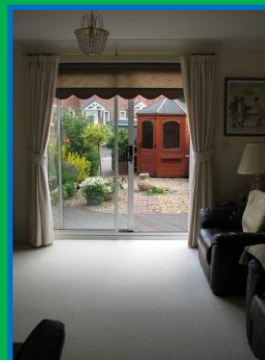
Although the floodwater quickly receded, the entire ground floor of the timber-framed property was left covered in thick mud. The elderly occupant needed to move back in as soon as possible, but it would take months for the property to be dried out completely using conventional methods.

Walls were stripped up to a metre high and all surfaces power-washed and sanitised, and a dehumidifier left in place for three weeks.

During week four a cavity drain membrane was fitted, the studded profile of which would allow the concrete block and beam floor to continue to dry out after installation. Floor and walls were then reinstated and fixtures and furniture replaced.
