PCA Case Study

Structural Waterproofing

A Victorian property in South Cambridgeshire with an existing basement converted into a playroom by the previous owner. There had been no attempt at waterproofing and 600mm of water was present in the basement, rendering it unusable.

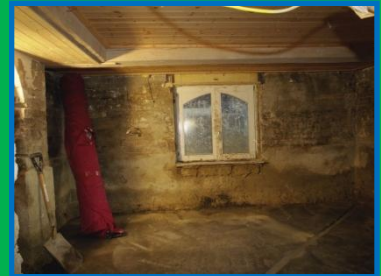
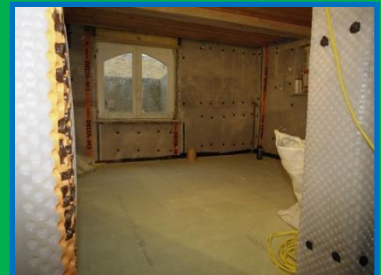
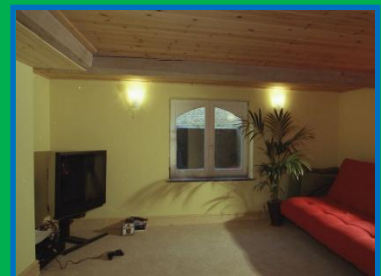
Cavity drain membrane was supplied and fixed to the walls by qualified and experienced technicians. A new chipboard floor was laid and a plasterboard and skim finish applied to the walls
